# ULTIMATE PULL TEST

YINTEC

BI-FOLD LOUVRE

AZT0008.16

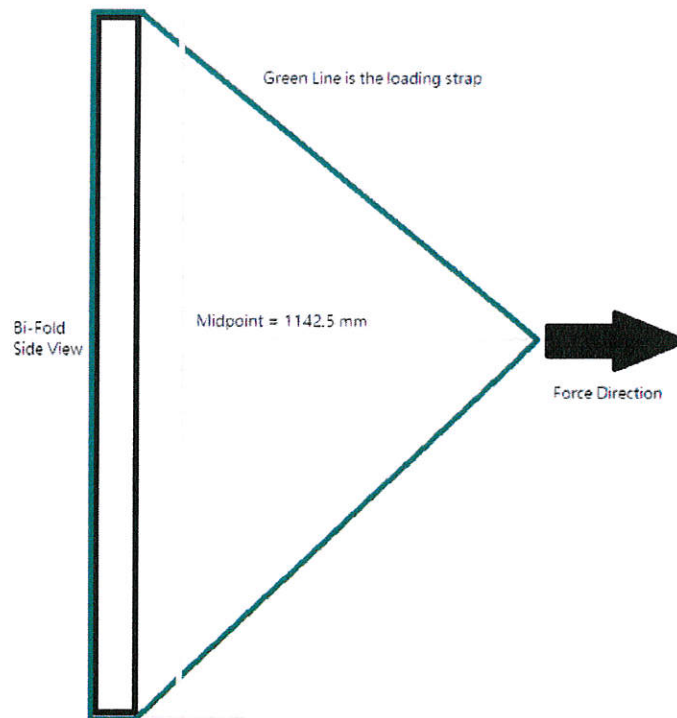
Figure 1: Drawing of Test 1 Layout

1. The test specimen was set up in the cannon test rig and clamped securely to the frame
2. The product was closed and locked
3. A strap was wrapped from top on the bottom of the meeting stile and joined to the load cell in line with the center of the sash
4. The force was increased until breakage occurred
5. The force is recorded and the damage to the test specimen noted

Force Reached Before Breakage	1057.9 N ± 0.1 N
-------------------------------	------------------

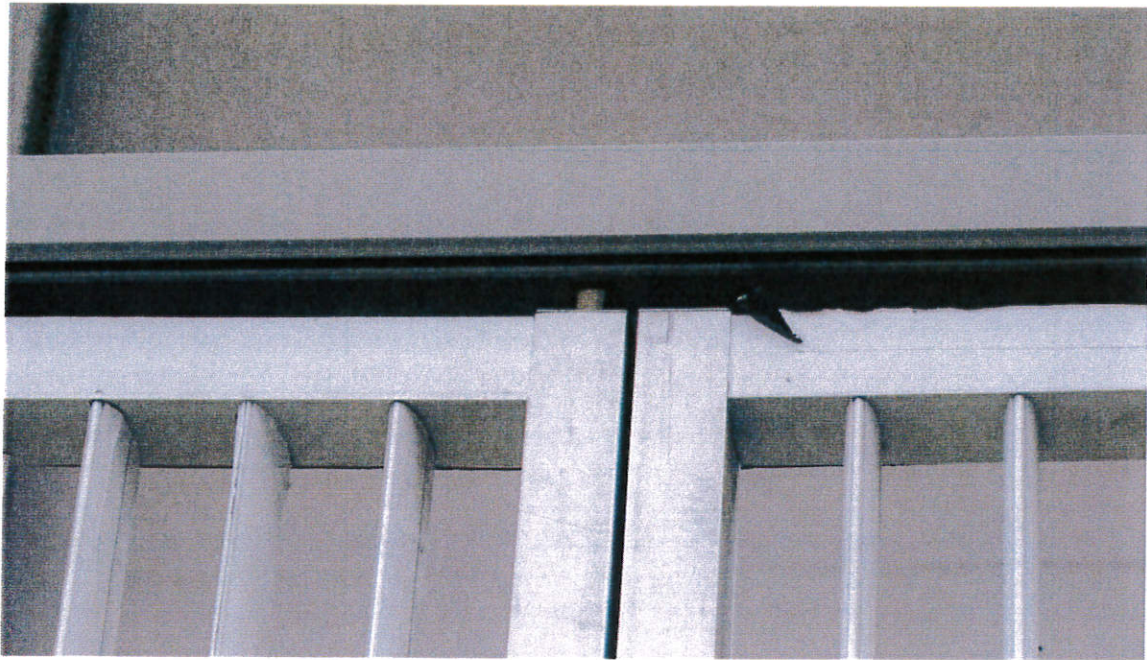
Figure 4: Damage observed on Lock Bar

The results from test 1 showed that the product could withstand 1057.9 N of force before damage occurred. The door was able to open due to the snapping of the locking leg cap, once this had snapped the door was able to open freely. No other damage was observed.

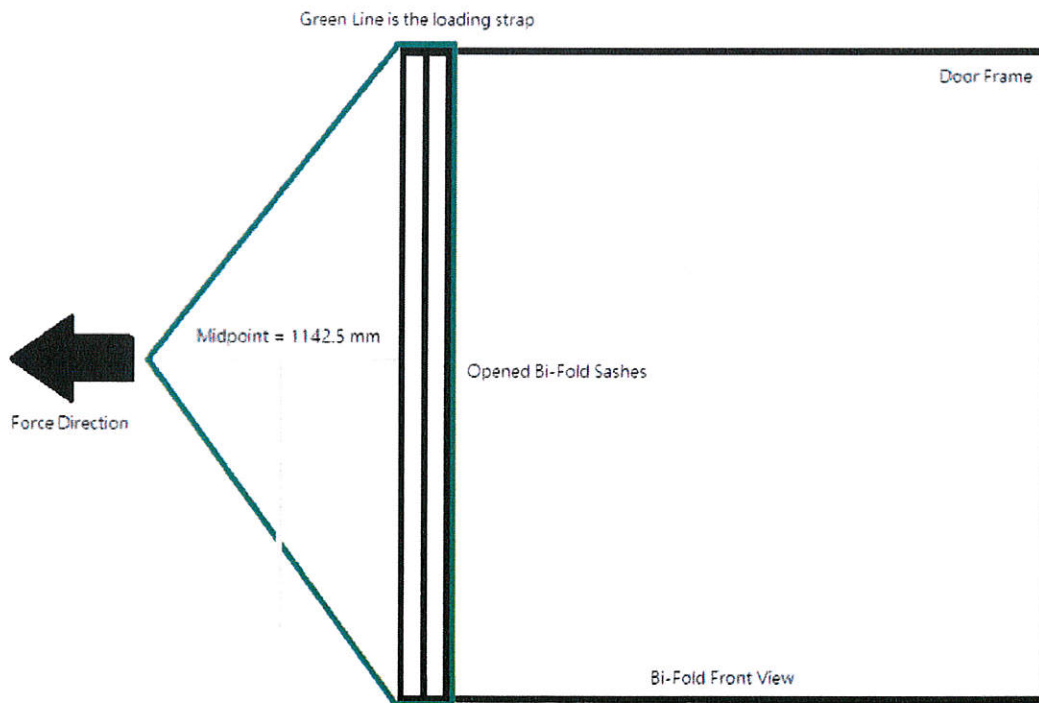
Figure 5: Drawing of Test 2 Layout

1. The test specimen was set up in the security door testing rig and clamped securely to the frame
2. The product was opened to its full extent
3. A strap was wrapped from top on the bottom of the meeting stile and joined to the load cell in line with the center of the sash
4. The force was increased until breakage occurred
5. The force is recorded and the damage to the test specimen noted

Force Reached Before Breakage	752.6 N ± 0.1 N
-------------------------------	-----------------

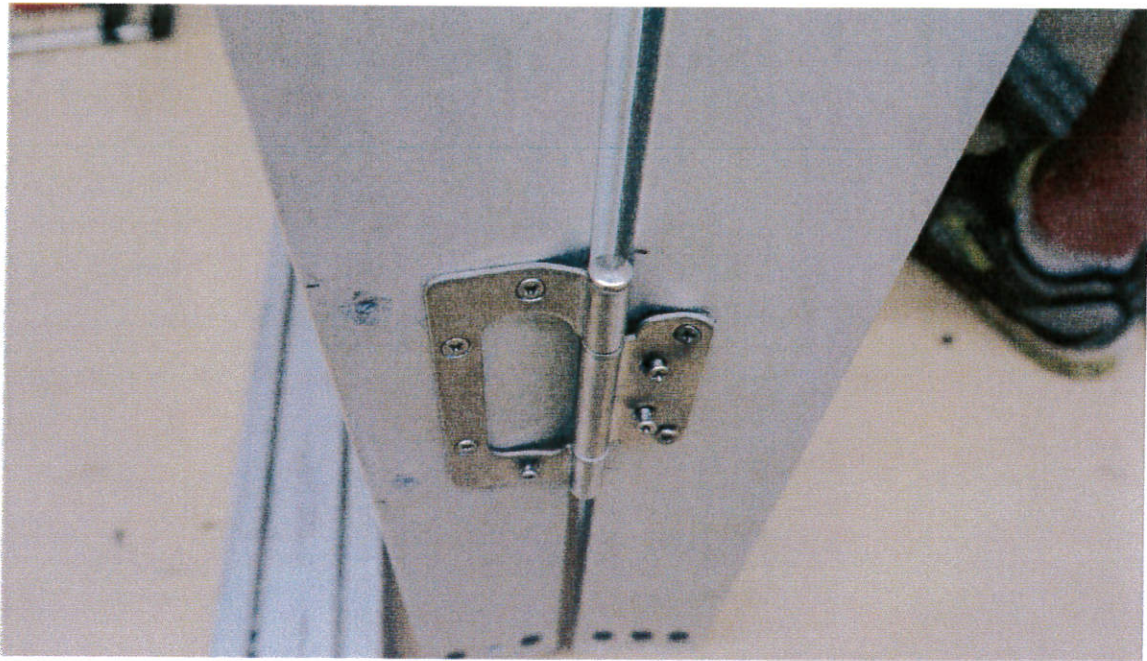
Figure 8: Bottom Hinge

The results from test 2 showed that the product could withstand 752.6 N of force before damage occurred. The door was pulled out of position as the bottom track roller had snapped off, hinge screws were pushed out as the hinge material became bent. The sash furthest from the pull direction began to pull apart the sections of extrusion. The sashes however remained attached to the frame as the top roller had not dislodged and remained functional.
